**DETERMINATION OF OPTIMUM FABRICATION
TECHNIQUES FOR THE PRODUCTION OF
AUSTENITIC REFRACTORY BIMETALLIC TUBING
MIDPOINT REPORT**

National Aeronautics and Space Administration

Under Contract NAS 3-10601

Westinghouse Electric Corporation

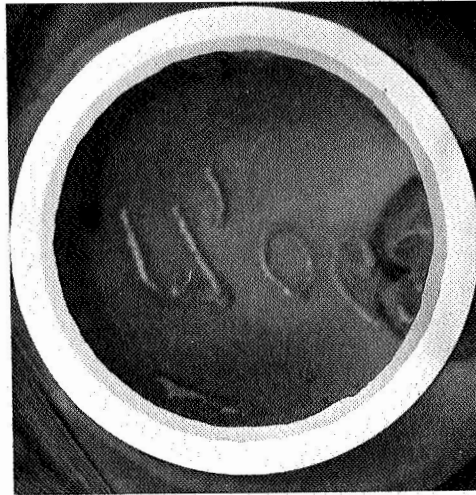
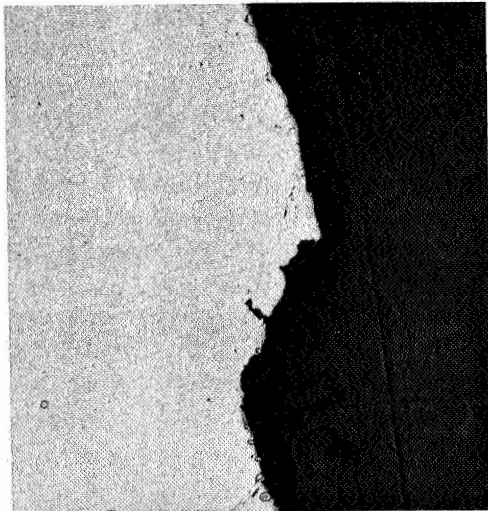
Figure 6. As-Received Metalonics Ta/316SS Bimetal Tubing

- a) a rough interface
- b) an ID surface roughened by longitudinal striations about 2-3 mils deep and occasional cracks of varying depth
- c) a smooth OD surface containing several cracks of varying depth.

These features are shown in Figure 6.

(a) Transverse Section 3X

(b) ID Crack, ~2 Mils Deep 100X

(c) OD Crack ~7-1/2 Mils Deep 100X

Extensive sectioning of the type of tubing seems to indicate that the majority of the cracks identified by dye penetrant testing of the OD are about 5 mils deep and also that the majority of ID cracks are about 2-3 mils deep. (See Figure 6)
